A TO Z HOME INSPECTIONS

Home Inspection Report

1234 Main Street

REPORT NUMBER:
REP001977

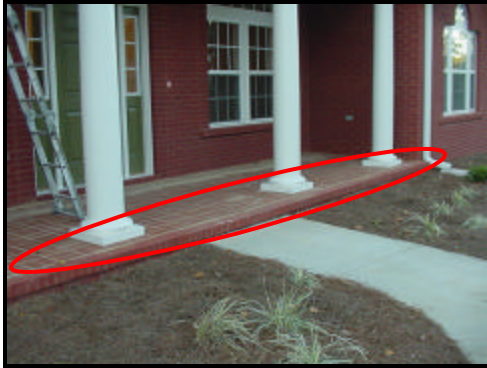
SAFETY: The brick pavers at the front porch are raised above the edge brick creating a trip hazard that could cause injury. Repair or replacement is needed.

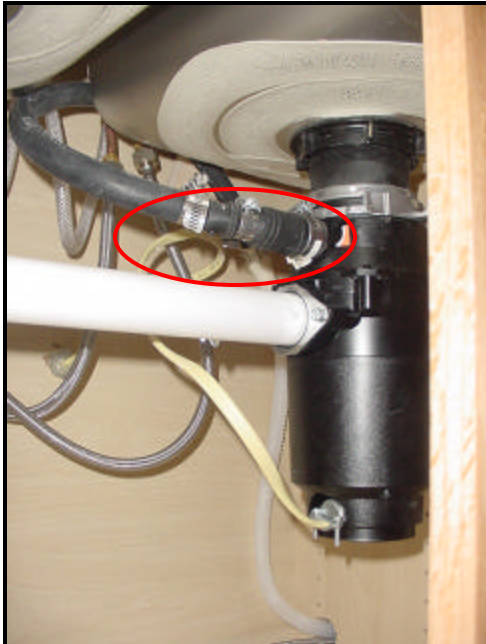
REPAIR: The dishwasher drain connection under the kitchen sink leaks and should be repaired.

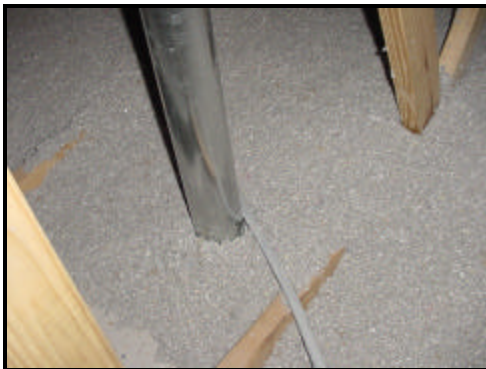
REPAIR: The electric cable at the water heater vent pipe should be moved so that there is at least one inch of clearance between the cable and the vent pipe.

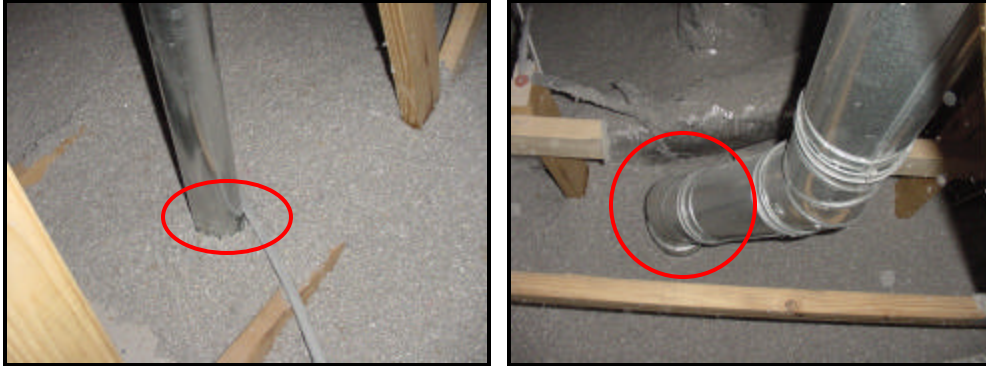
REPAIR: The fireplace and water heater vent pipes are required to have one inch of clearance to all combustibles including insulation. This requirement is stamped into the metal vent pipes. Repair is needed.

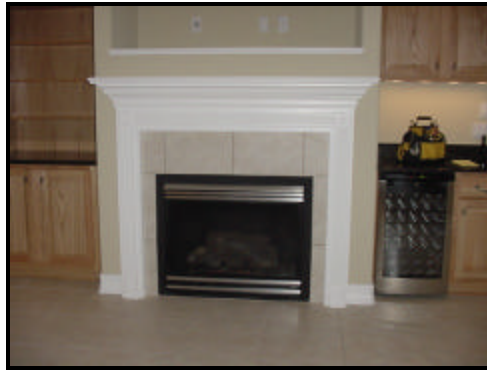
The fireplace appears to be operating as expected.
