A TO Z HOME INSPECTIONS

Home Inspection Report

1234 Main Street

REPORT NUMBER:
REP001977

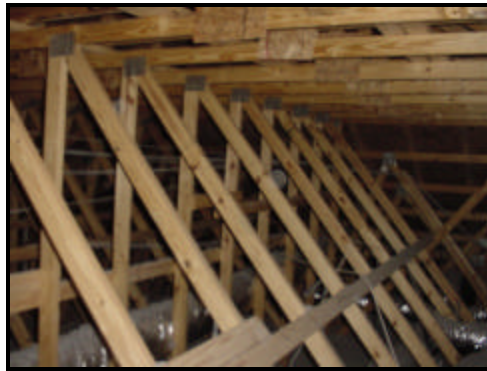
The subject residence is a one story detached, wood frame, single family dwelling and is a brand new home that has never been lived in. The residence has four bedrooms, one kitchen, three bathrooms and is built on a slab-on-grade. Wall framing is 2 by 4 studs on 16-inch centers sheathed with oriented strand board (OSB). The ceiling joists are 2 by 4. The roof is a manufactured truss assembly; the rafters are 2 by 4 and 2 by 6 on 24-inch centers sheathed with spaced sheathing. The foundation is conventional poured concrete design.

The attic was inspected using a flashlight. The attic access location was a ceiling hatch in the garage.

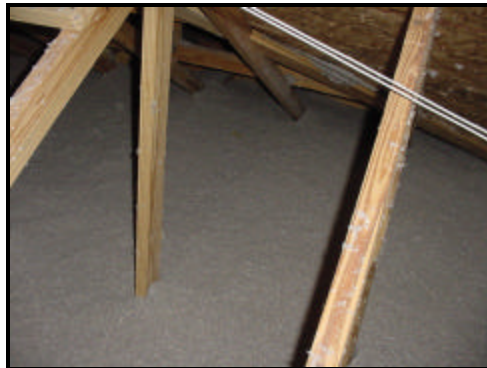
The main attic section is insulated with 12 inches of fiberglass batting and cellulose. The insulation level in the attic is to current code. This roof/attic configuration uses passive ventilation and has under-eave intake vents consisting of holes cut in the soffit that are either screened with mesh or covered with louvered material. There are ridge vents used along the ridge of this attic/roof assembly to exhaust air. Like other types of vents, these enable air entering the roof/attic near the eaves to rise through convection toward the ridge and then leave the roof envelope. Since ridge vents are continuous, they provide more efficient movement of air out of the roof system than gable, roof or slot vents. The roof/attic ventilation appears to be functioning normally and is adequate for a home of this size.
